Leibniz Supercomputing Centre

Liquid Cooling Commissioning Lessons Learned @LRZ

EE HPC WORKING GROUP, SC13, Denver, Nov. 17-22, 2013

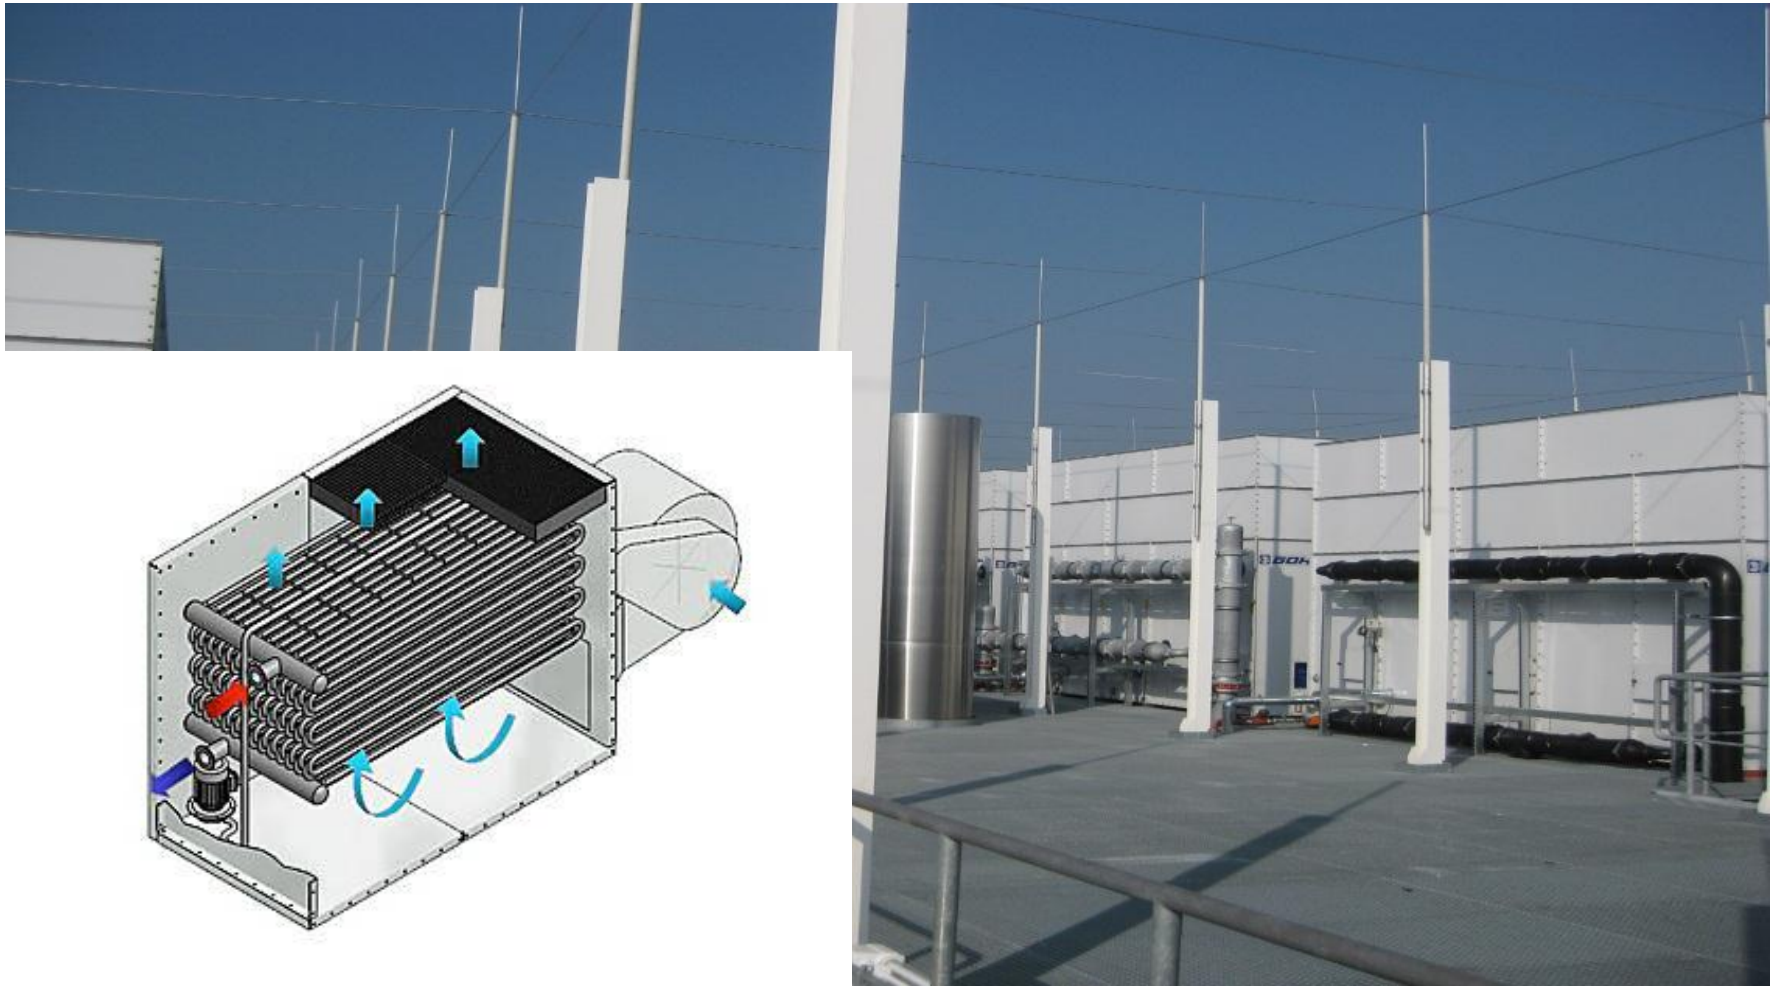
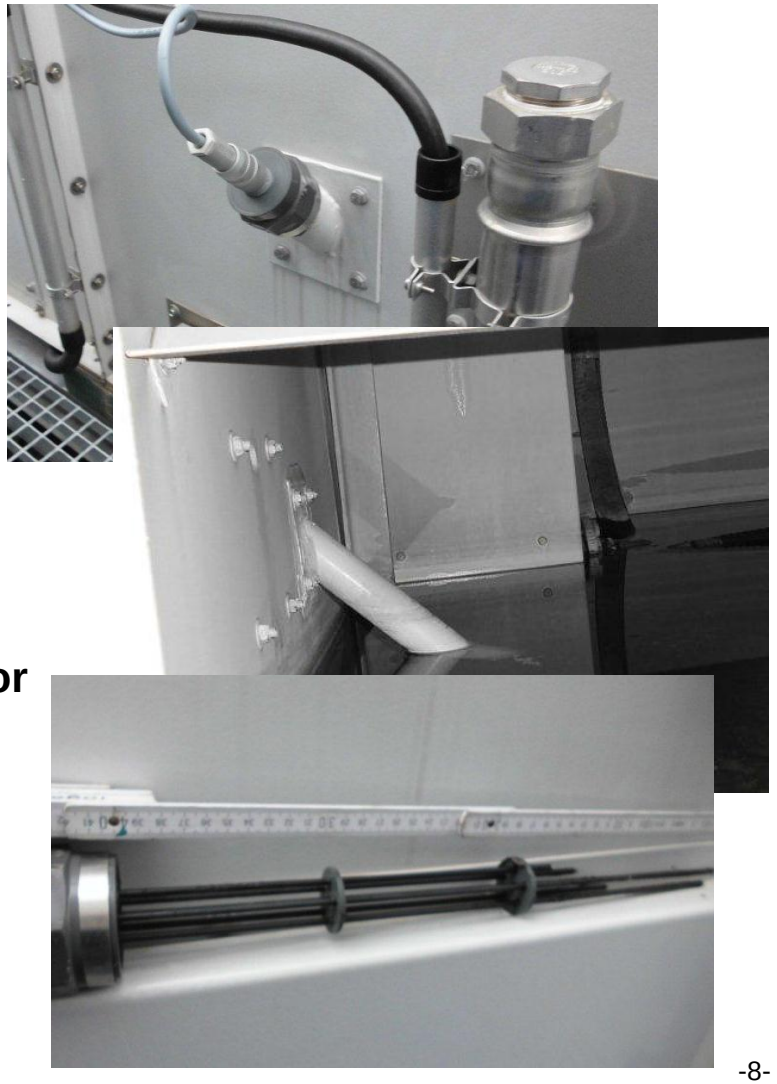
CASE #1: Cooling Towers

Malfunction of Water Level Sensors

- **Issue:**
  - Water demand cooling loop increased
    - Filling volume: 7 m³
    - Typical feed: 1+ m³/h
    - Observed losses: 1 – 2 m³ in hours or days
- **Investigations:**
  - Load tests of the cooling towers
  - Inspection of the control system
  - Examination of the measuring devices
- **Reason:**
  - Wrong dimensions of the filling level sensor installed
- **Root cause:**
  - Main contractor did not use the sensor recommended by the manufacturer of the cooling tower

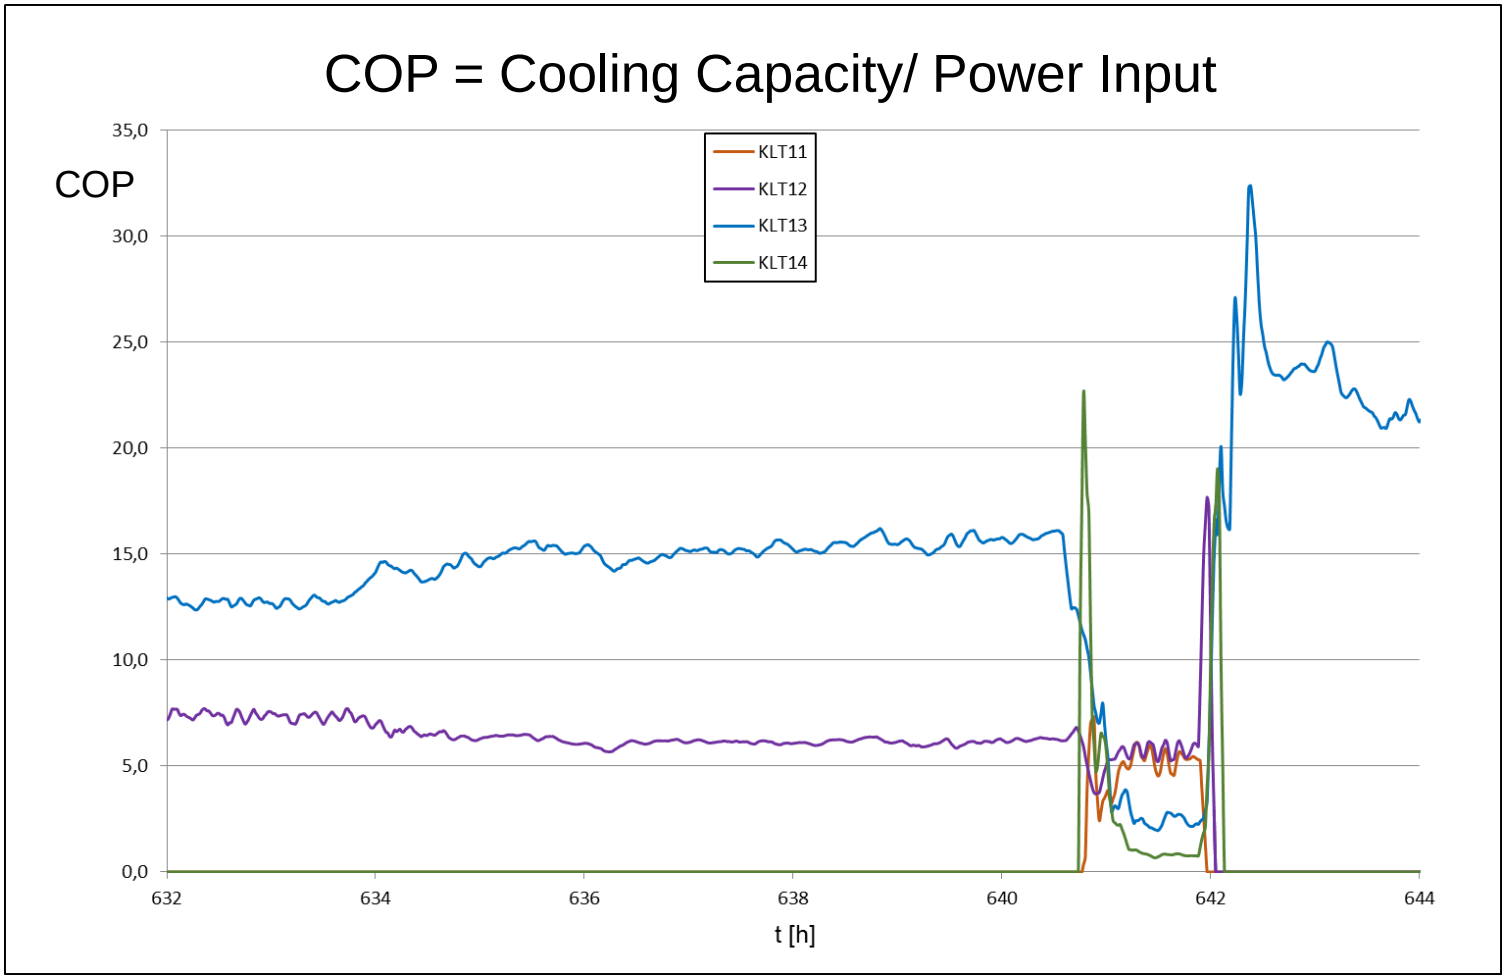
Operating Control: Test of ΔT_{inlet}(NSR) = -20 K

Response of Warm Water Cooling Infrastructure
